RE: Irrigation Audit Report

Irrigation Audit Report Rainbird PRS Field Study

College Station, Texas

Site #1, Canyon Creek Townhomes
Controller Station 3, Property Entrance

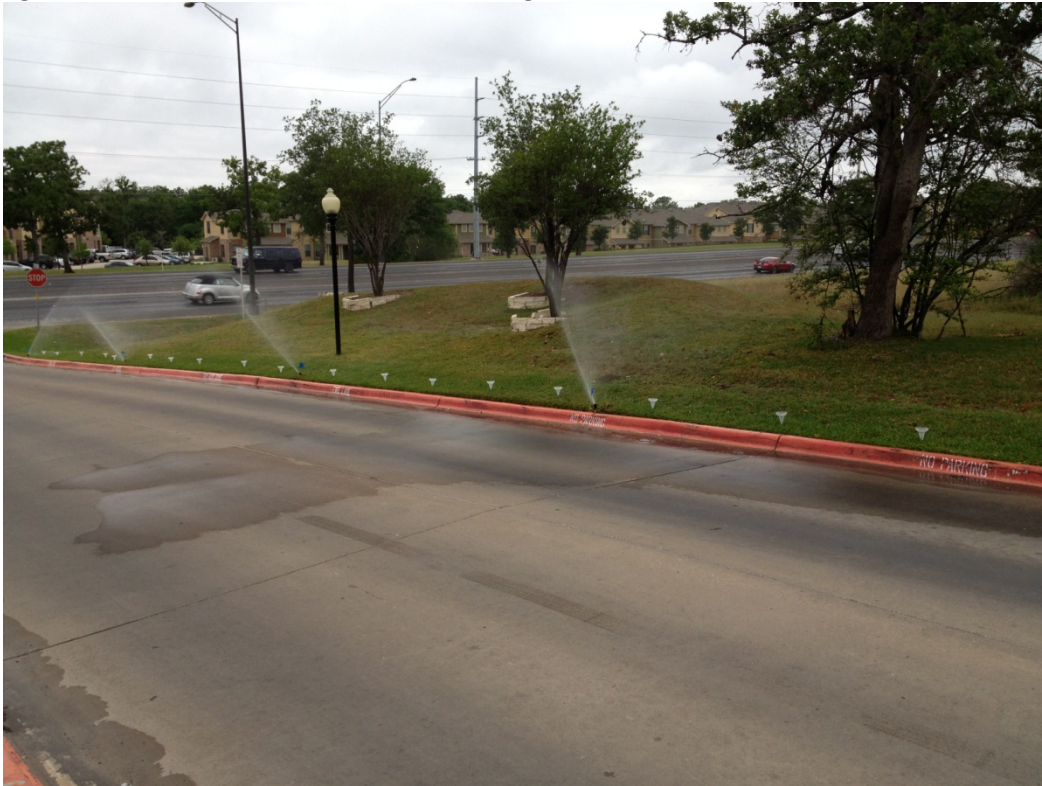
Figure 1. Site #1, Catch Can Test with Existing Rotors

The irrigation system at the property entrance of Canyon Creek Townhomes (Site #1) had high pressure and operated during wind conditions. During the initial catch can test with the existing rotors, some misting was observed resulting in a low uniformity for both DULQ (44-52%) and CU (56-63%) even though the irrigation system hardware was in good condition. Following the retrofit to the Rainbird PRS rotors, uniformity increased for DULQ (65-67%) and CU (76-77%).

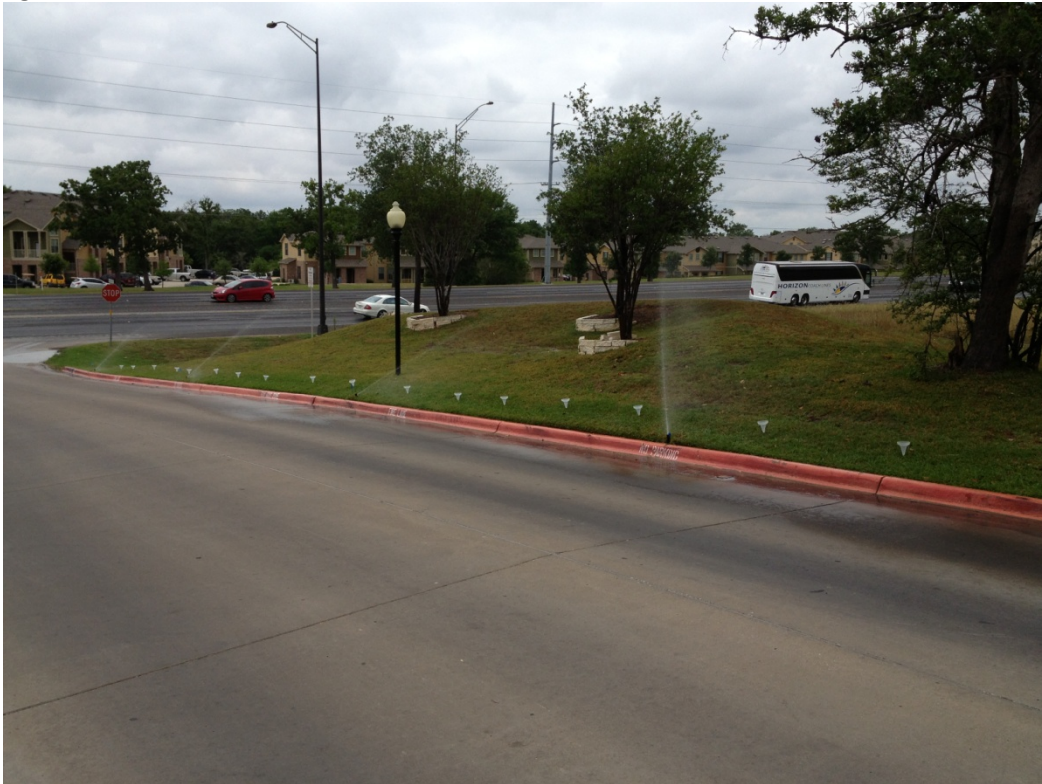
Figure 2. Site #1, Catch Can Test with Rainbird PRS

Water meter analysis also showed a 23% decrease in water use while maintaining the similar precipitation rates.
